## TEST REPORT

No. : NBIN1911013300SC

Sample Name : PVC FLOOR TILE  
Product Specification : 4mm  
Product or Lot No. : Vinyl floor 01

Test item: Heat Resistance

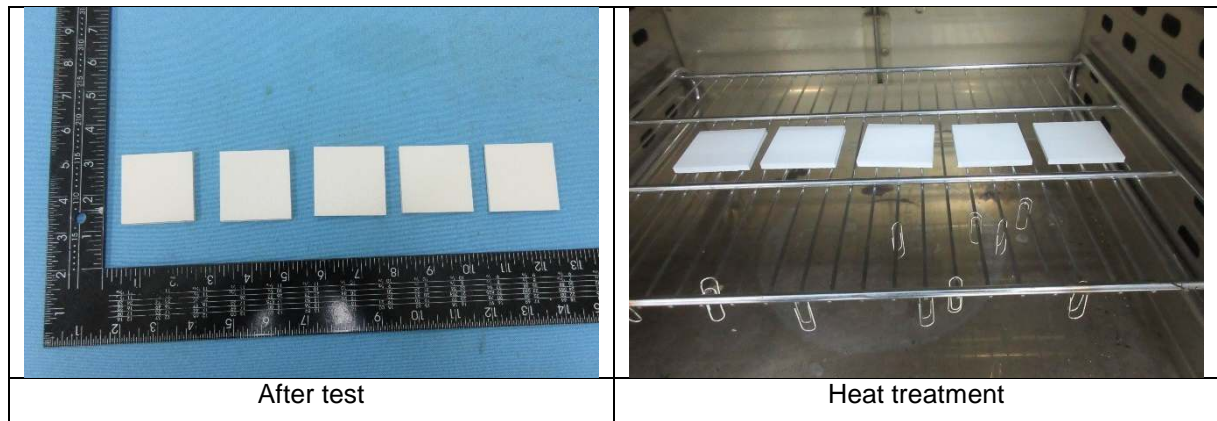
Test Photo:

Test condition: Heat treatment condition: 70°C, 7d

Sample	Test item	Result
Sample B	Heat Resistance	$\Delta E^*_{ab} = 6.0$ note

After test Heat treatment

Note:  $\Delta E^*_{ab}$  is measured by sphere spectrophotometer. Use D65 standard light source with 10° observer. SCI: Specular included.
